**POST-OCCUPANCY EVALUATION:  
A NECESSARY TOOL FOR ARCHITECTS,  
FACILITIES MANAGERS AND OTHER  
PROFESSIONALS IN THE BUILDING INDUSTRY**

**PROF. STELLA NONYELUM ZUBAIRU**

**INAUGURAL LECTURE SERIES 68**

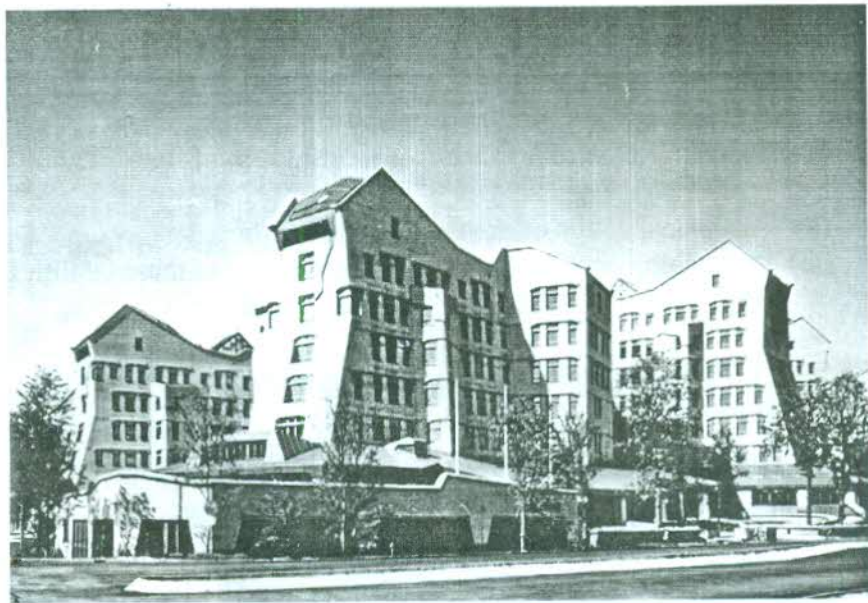
The building was designed by Ton Alberts of Alberts and Van Huut and the unique configuration was to ensure that workstations were as close to windows as possible (see Plate 2.1)

Plate 2.1 - NMB (now ING) Headquarters, Amsterdam, Netherlands  
Source: *Architecture Guide* (2018)

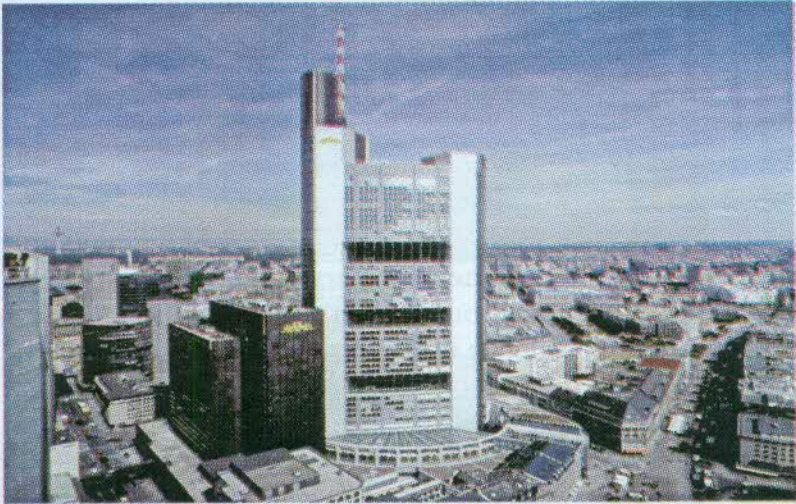
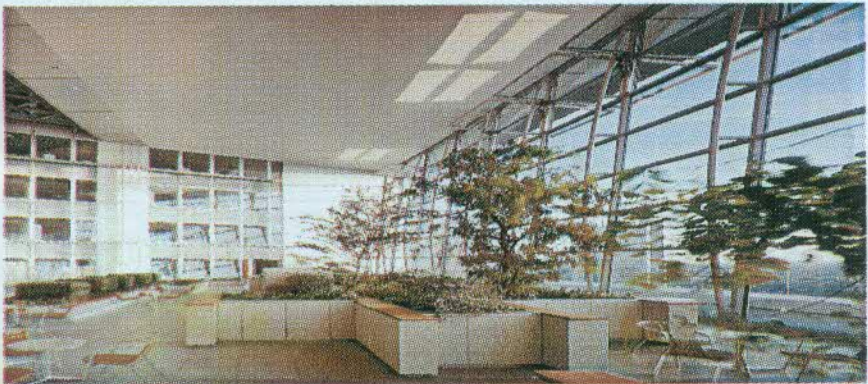
The building was designed by Sir Norman Foster and was the first eco-friendly skyscraper in Europe when completed in 1997. The design utilises natural ventilation and allows users to be able to open windows to a beautifully landscaped atrium (see Plates 2.2 and 2.3).

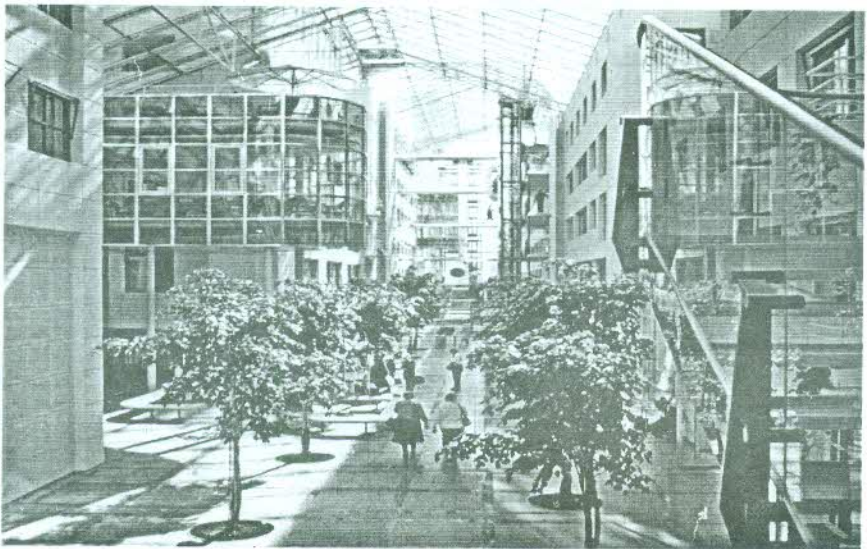
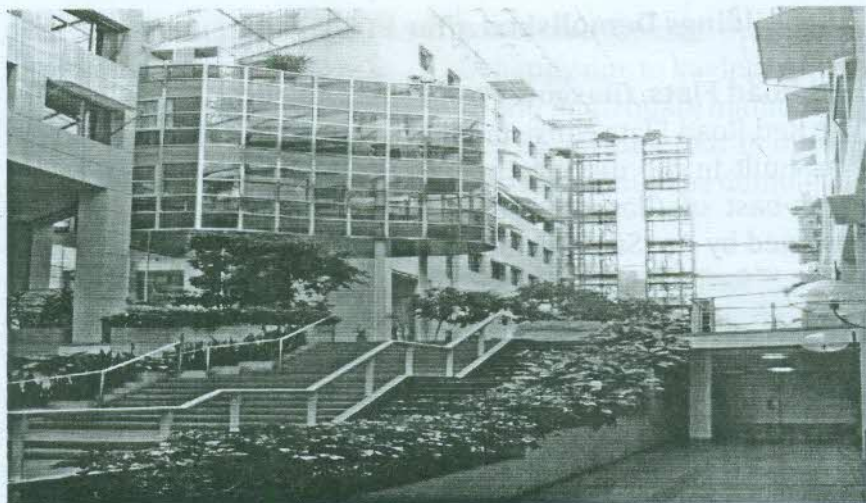
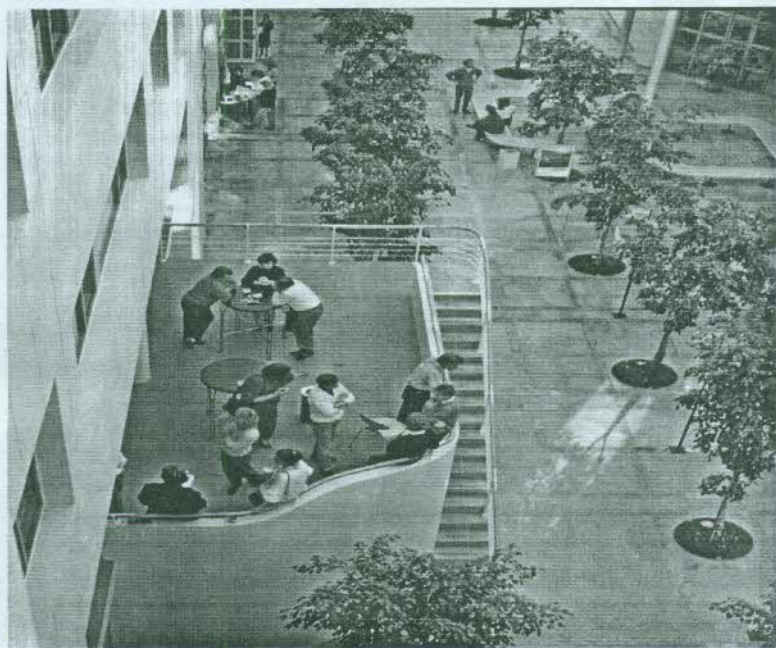
The building was designed by Norwegian architect Niels Torp and took two years to build from 1985 to 1987. It has seven separate building blocks with a 'street' covered by a glass roof connecting the corridors (see Plates 2.4, 2.5 and 2.6).

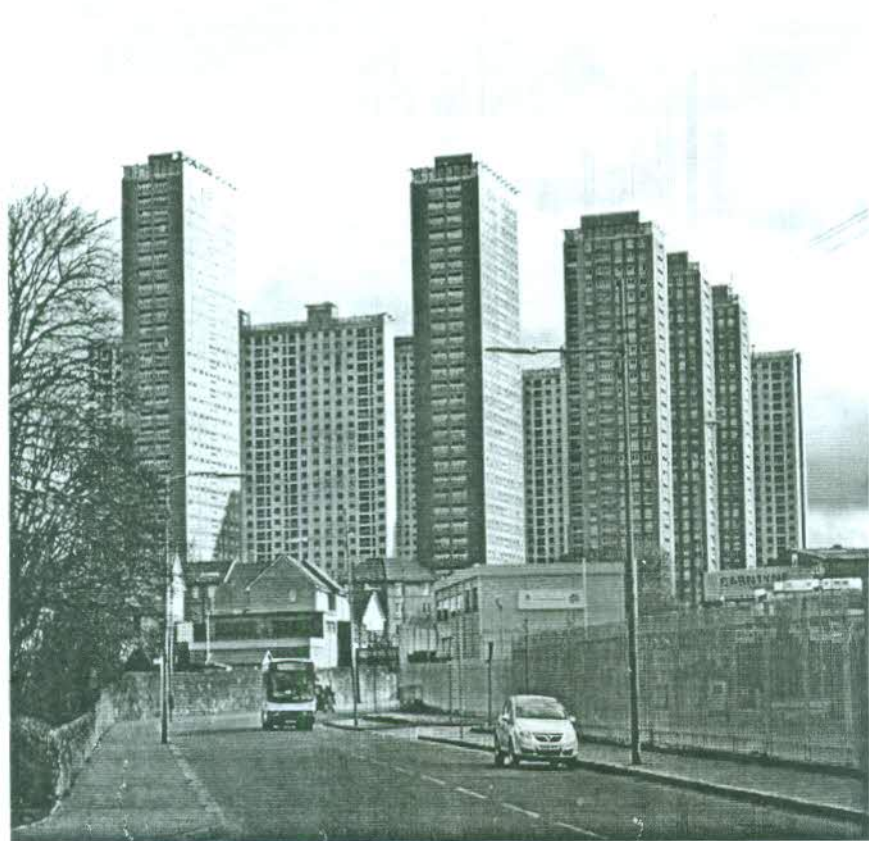
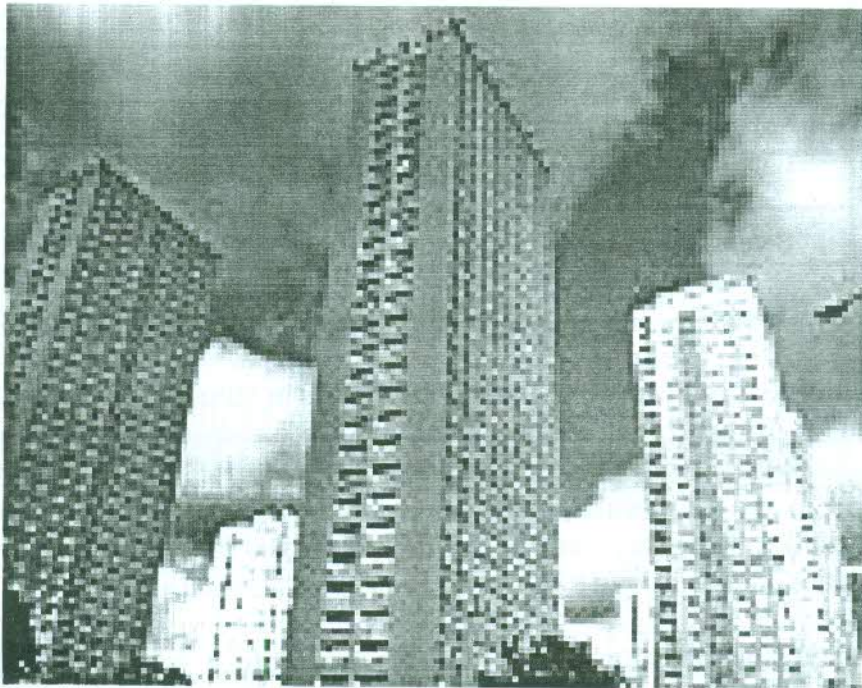
The Red Road Flats consisted of 8 blocks of high rise residential flats built in the districts of Balornock and Balmulloch in the north-east of Glasgow (see Plates 2.7 and 2.8). They were designed by Arc Sam Burton and associates. Two blocks had 28 floors (79m) while six blocks had 31 floors (89m). Construction was completed in 1968 while the opening was in 1971 (Smith, 2010).

POE revealed that asbestos was used to clad the steel frame as fire protection. Also residents were not happy due to having to live so high above ground, high crime rate and inadequate maintenance of the buildings. It was after a series of suicides, four in number, that the government decided that the flats should be demolished. The demolition took place from 2012 to 2015.

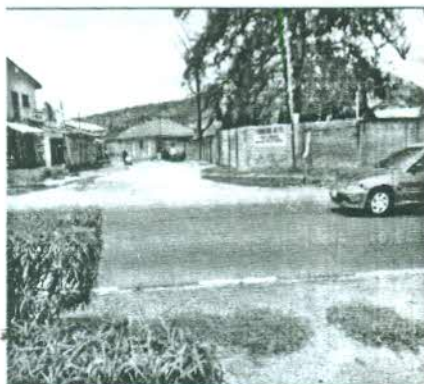
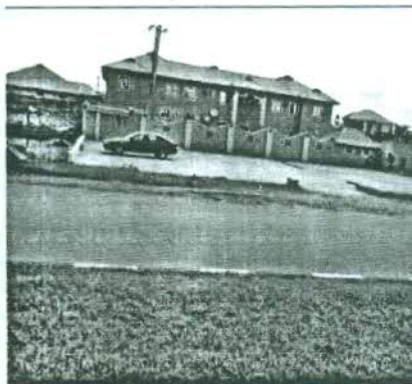
Plate 3.1 - Good access road

Plate 3.2 - Good access road

Plates 1 and 2 represent the hotels that enjoy locational advantage, proximity to bus route and good condition of adjacent street.

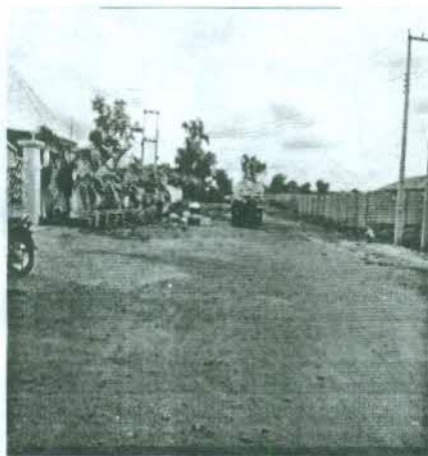
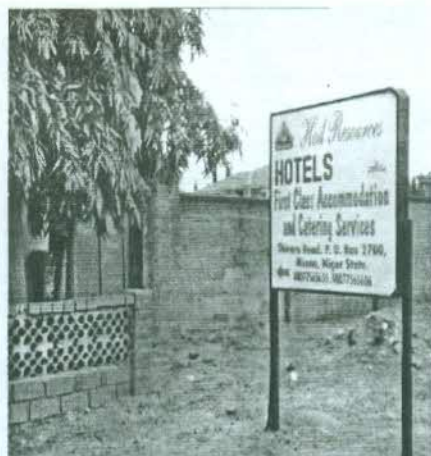
Plate 3.3 - Bad access road

Plate 3.4 - Bad access road

Plates 3.3 and 3.4 represent the hotels with bad location.

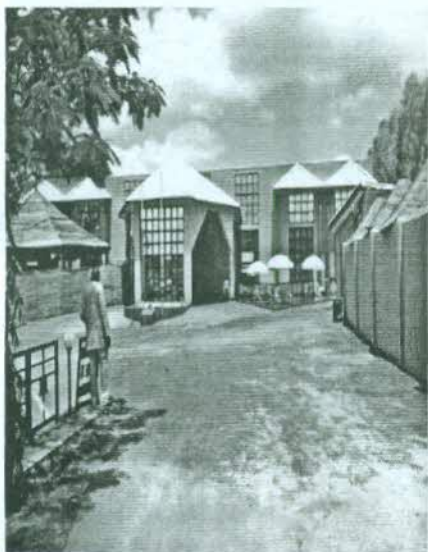
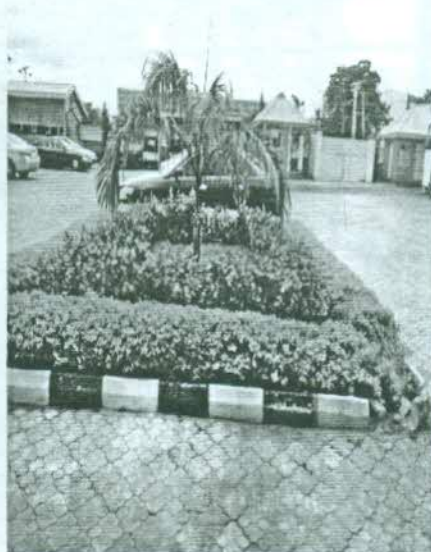
Plates 3.5 and 3.6 represent hotels with attractive external image and good landscaping.

Plate 3.5 - attractive external image

Plate 3.6 - good landscaping image

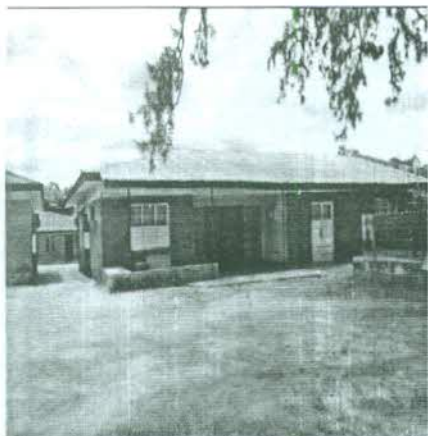
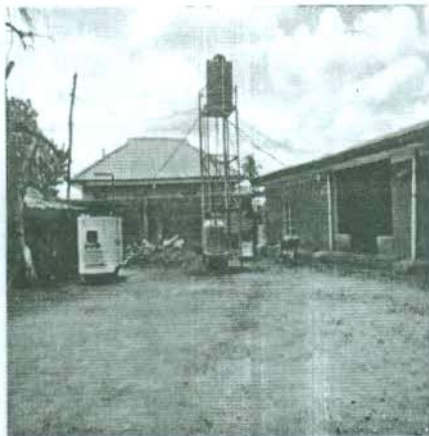
Plate 3.7 - Poor external image

Plate 3.8 - Poor external image

Plates 3.7 and 3.8 show hotel with bad external image and landscape  
Plates 3.7 and 3.8 show hotel with bad external image and landscape

- Additional facilities should be provided by most of the hotels in order to attract more customers; recreational facilities like gymnasium and swimming pool, should be provided in the hotels for customer satisfaction and convenience.
- The hotel owners/operators should tap the enormous opportunities offered by Post-Occupancy Evaluation method of building appraisal. This helps in ensuring improved business performance.
- The government should improve on the quality of power and water supply in the State.
- Aesthetics should be given a high priority. Building users derive a lot of psychological satisfaction and aesthetic pleasure if the premises are well maintained and landscaped.

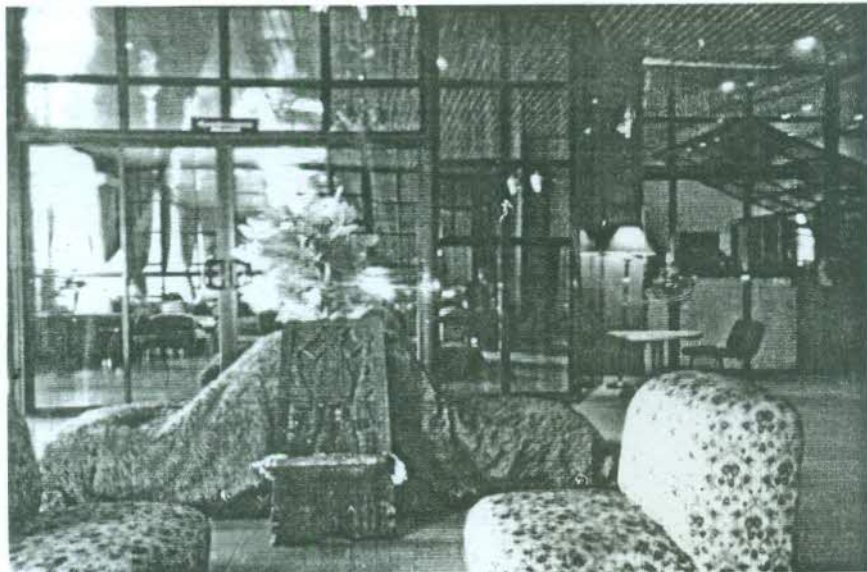
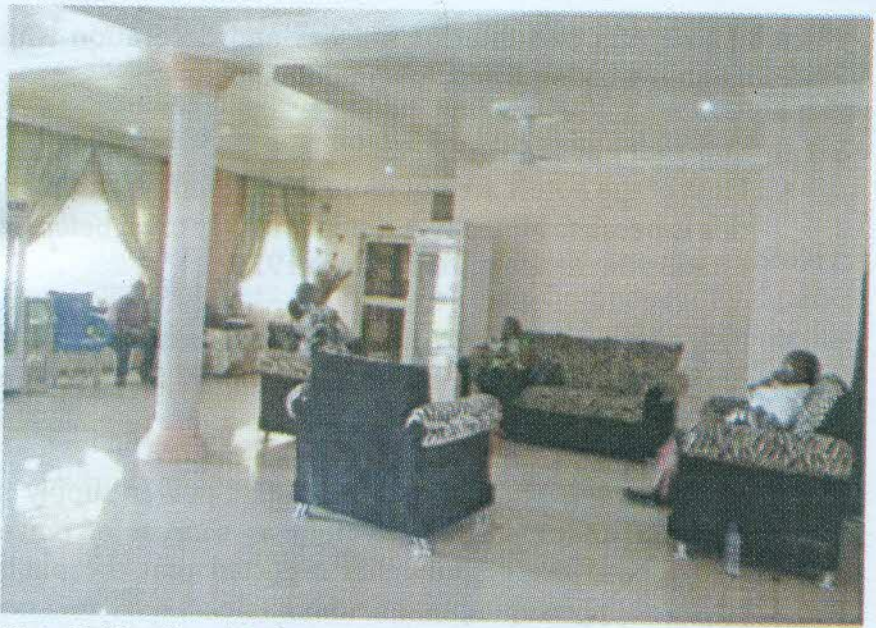
Plate 3.9 - Good indoor image

Plate 3.10 – Good indoor image

Plates 3.9 and 3.10 show hotels with good indoor cleanliness and interior decoration.

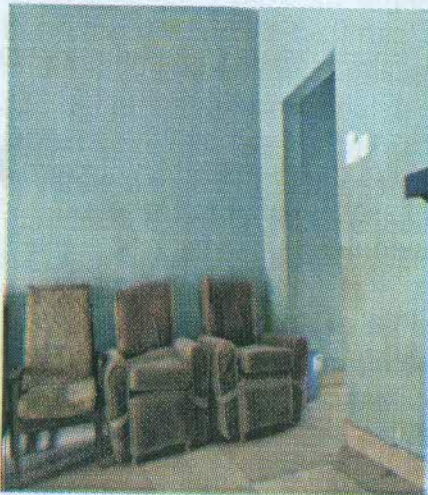
Plate 3.11 - Poor interior

Plate 3.11 depicts bad interior finishes and decoration while plate 3.12 shows bad wall and floor maintenance.

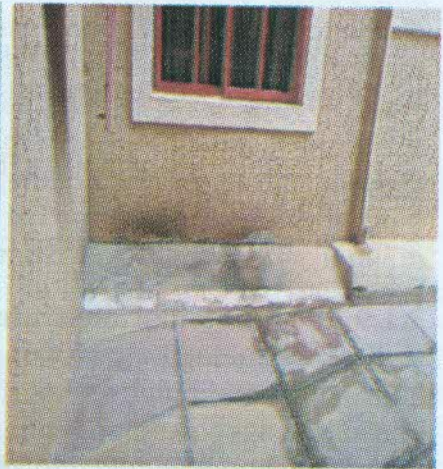
Plate 3.12 - Poor wall and floor maintenance

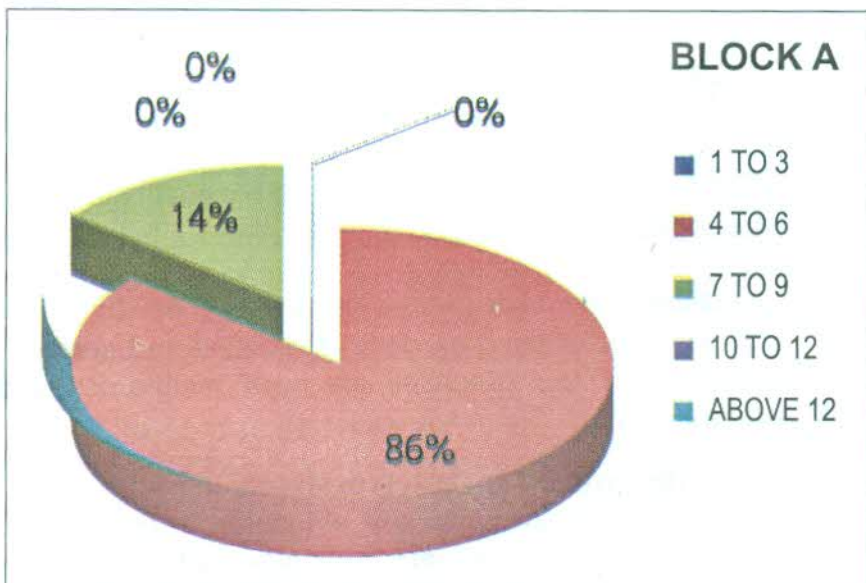
allocation of 4 students per room, the study revealed that 86% of rooms studied have between 4-6 students, while 7-9 students are resident in the remaining 14% of rooms, (see Figure 3.1). This shows that overcrowding exists in 14% of the rooms in this hostel. It is important to note that the rooms were neither below the statutory allocation nor were they grossly overstretched.

Figure 3.1: Occupancy of Block A

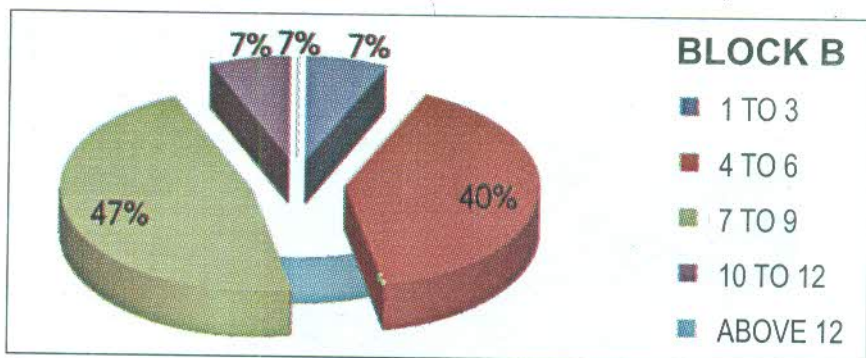
In Hostel B (male) – Gidan Kwano (see Plates 3.13 3.14) which similarly has a statutory allocation of 4 students per room, the study indicated that 7% of respondents rooms have 1-3 students in a room, 40% have 4-6 students, 46% have between 7-9 students and a further 7% have 10-12 occupants while none of the rooms studied have more than 12 occupants, (see figure 3.2). 53% of the can be said to be overcrowded and 7% are under occupied. Hostel B can therefore be said to be overstretched in terms of its occupancy.

Figure 3.2: Occupancy of Block B

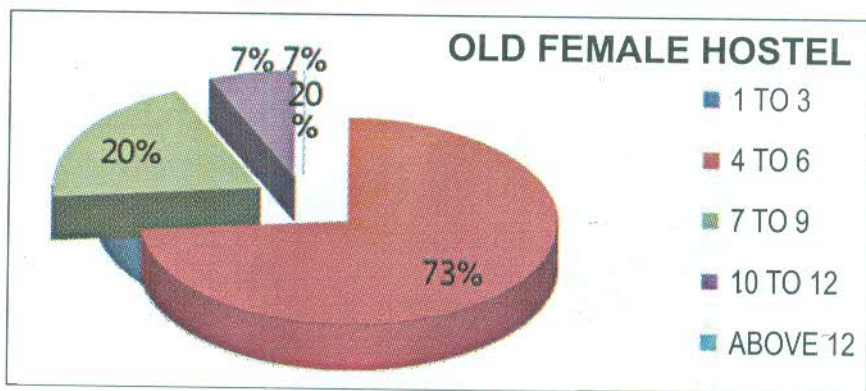
The Old female hostel in Gidan Kwano campus comprising blocks C, D, E, F, G has legal occupancy of 5 students per room. Studies showed that 73% of rooms have 4-6 occupants per room, 20% have 7-9 occupants and 7% have 10-12 occupants while none had 1-3 occupants or above 12 occupants, (see Figure 3.3). This Hostel can thus be said to have overcrowding in 27% of rooms.

Figure 3.3: Occupancy of Block C, D, E, F and G.

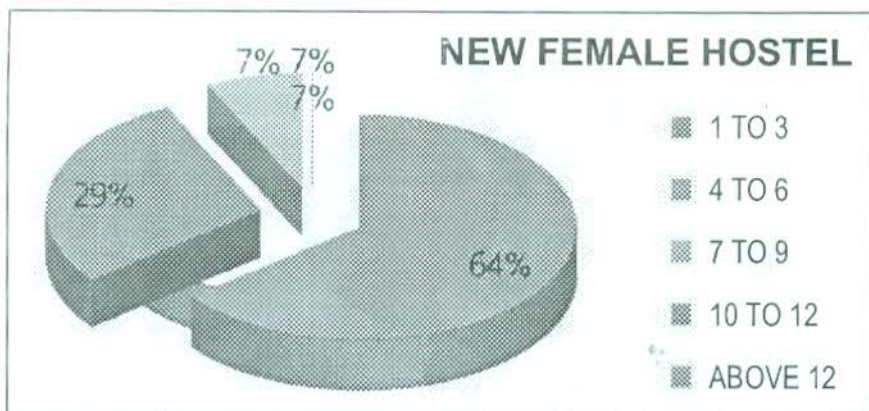
In the new female hostel, Gidan Kwano whose legal occupants per room is 3, the study revealed that 64% of rooms are optimally occupied by 1-3 occupants while 29% of rooms are occupied by 4-6 students, 7% have 7-9 students, (see Figure 3.4). 36% of the rooms in this hostel are overcrowded.

Figure 3.4: Occupancy of New Female Hostel

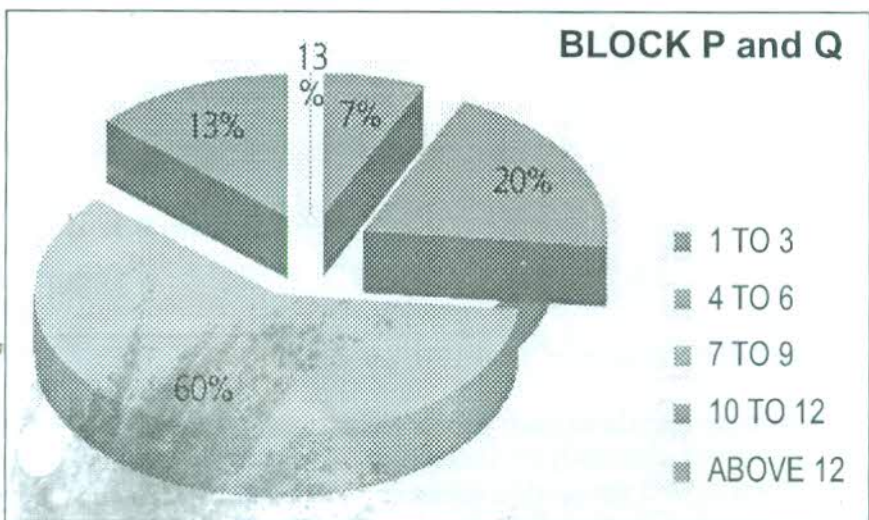
In Bosso Campus, Block P (male) and Block Q (male) posed identical results with 60% of the rooms studied having 7-9 occupants, 20% have 4-6 occupants, 7% have 1-3 occupants while 13% are occupied by 10-12 students, (see Figure 3.5). Since these hostels have a statutory allocation of 8 students per room, then 13% of them can be said to have overcrowding issues while 27% are under occupied!

Figure 3.5: Occupancy of New Female Hostel.

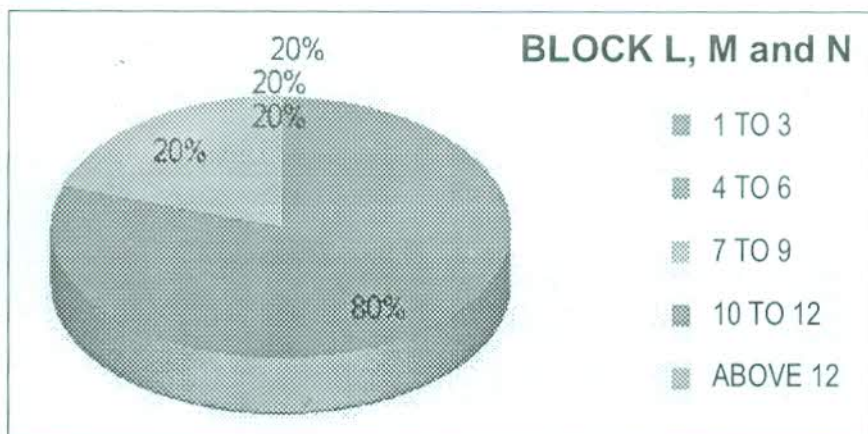
In Block L and M and Block N (female) hostel located in Bosso campus, the result show that 80% of the hostel has 9-12 students per room while 20% have above 12 rooms, (see Figure 3.6). As its statutory allocation is 9 per room, 20% can be said to be overstretched.

Figure 3.6: Occupancy of Block L, M and N

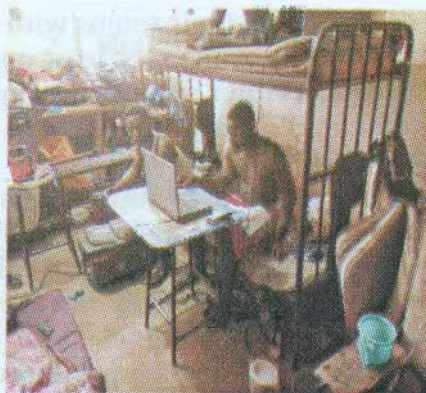
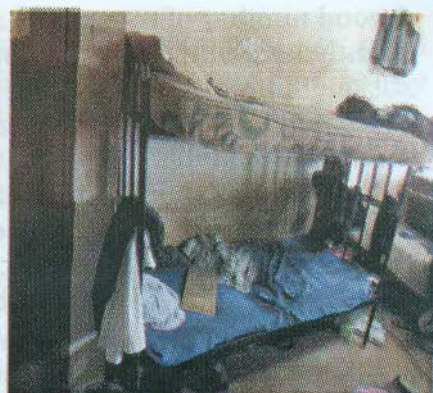
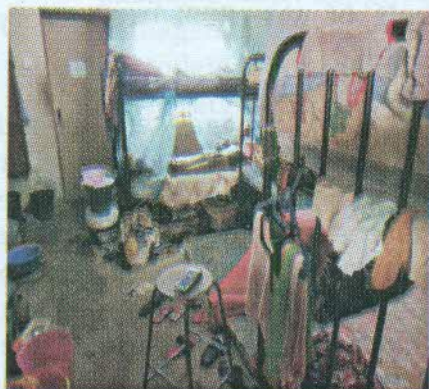
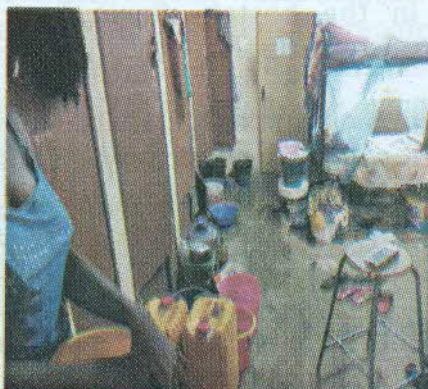
Summarily, about 34% of hostel rooms in Gidan Kwano campus are overstretched while only 17% of rooms in Bosso campus were congested. The male hostels had overcrowding issues in 27% of its rooms while their female counterparts similarly had 27% overcrowding in their rooms. In general, overcrowding in rooms can be put at 27%. Plates 3.15, 3.16, 3.17 and 3.18 illustrate overcrowded rooms in the hostel.

Plate 3.15 Overcrowded room in male hostel

Plate 3.16 Overcrowded room in male hostel

Plate 3.17 Overcrowded room in female hostel Gidan Kwano

Plate 3.18 Overcrowded room in female hostel Gidan Kwano

- Minimizing the level of room occupancy to avoid overcrowding which can contribute to unhealthy environment, and which could eventually cause the spread of air borne disease to the students. This can be achieved by proper monitoring on the part of the university management.
- The University management should outsource maintenance management aspect of the student housing in terms of adequate services and facilities provided to serve the students. The services and facilities such as adequate water supply, electricity, regular waste disposal management, maintenance of drainage system and repair of toilets/baths should be the major focus of the university management as these will help in improving student hostel satisfaction.

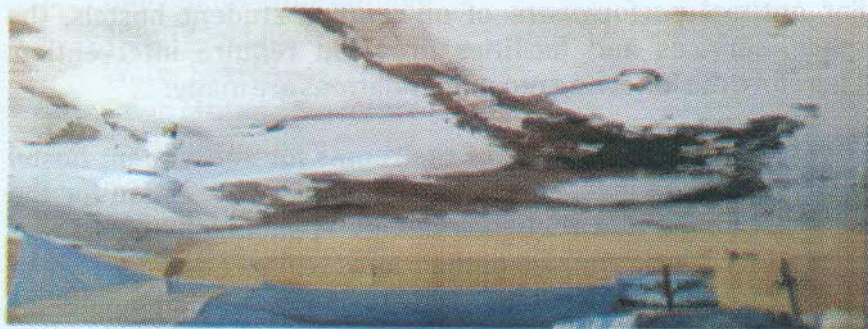
**3.2.2 Other facilities in the hostels** - The POE revealed that students made many illegal electrical connections in their rooms. Plate 3.19 illustrates such a connection through the ceiling fan in a room.

Plate 3.19 - Illegal connection from fan in male hostel

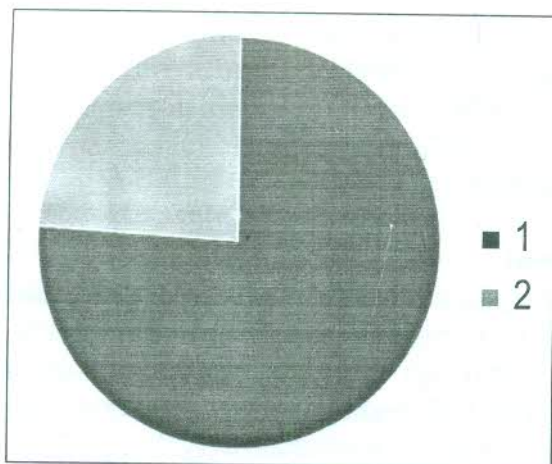
Figure 3.7: Showing the space management of factories in Minna

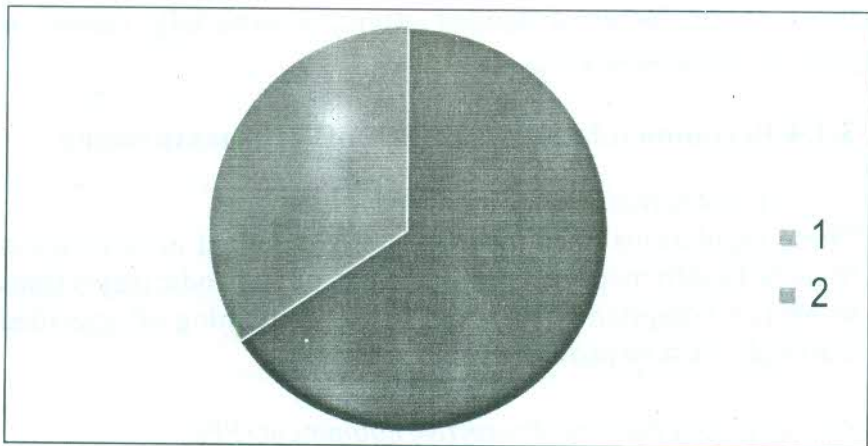
When workers are satisfied with their working conditions, they tend to be more productive. Table 3.5 indicates the level of satisfaction of the workers with their working environment. The results indicate that most of the workers were satisfied except for White Heart and Abu-Turab Feeds where 60% of the workers were dissatisfied with their working conditions.

Figure 3.8: Showing the user satisfaction of factory staff in Minna
